1. AGENCY USE ONLY (LEAVE BLANK)	2. REPORT DATE 5 September 1995	3. REPORT TYPE AND DATES COVERED Professional Paper	
4. TITLE AND SUBTITLE Developing Flight Test Techniques to Ensure Proper Rigging of Highly Augmented Aircraft		5. FUNDING NUMBERS 19951107 055

6. AUTHOR(S) CAPT Ricardo Traven, CAF Susan E. Whitley		8. PERFORMING ORGANIZATION REPORT NUMBER

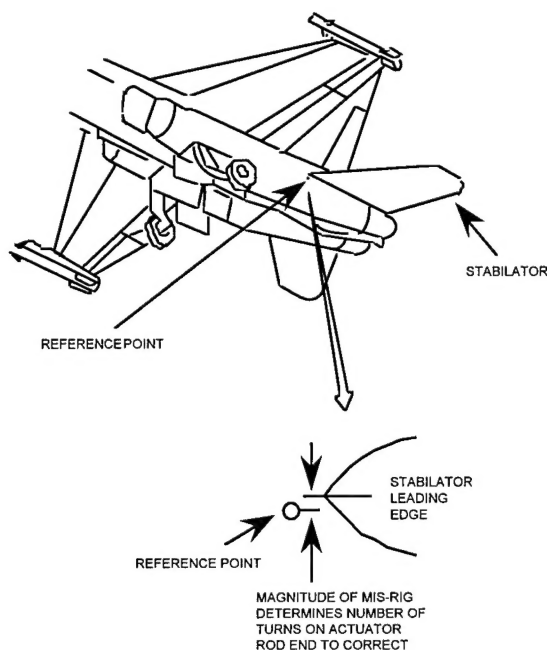
Figure 1
RIGGING REFERENCE POINT FOR THE
F/A-18 STABILATOR

The flight control surfaces are physically disconnected from the actuators during the rigging process. The surfaces are rigged either to a reference point on the fuselage or to another surface (the Production Zero Reference point) and then reconnected to the actuators. An example of the stabilator rigging reference point is presented in figure 1.

A flight control surface is considered to be mis-rigged if the distance between the Production Zero Reference point and the reference on the surface is beyond the allowable rigging tolerance. Rigging is performed on all flight control surfaces except the LEF's by converting the amount of the mis-rig in inches to a prescribed number of turns on the actuator rod end.

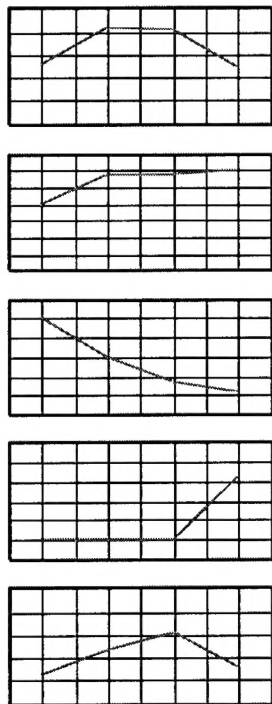
Figure 2
SIMULATOR MIS-RIG DATA

NAWC-AD used the F/A-18 simulation to collect uncommanded roll rate data for varying amounts of mis-rig on each flight control surface. This was accomplished by adding a bias to the surface to be mis-rigged to the FCC's calculated surface position commands. This biased surface position was then used for all further calculations, including aerodynamic calculations, feedbacks, etc. The bias was added to every frame to simulate a constant mis-rig. The simulator data show that small changes in the rigged position of a flight control surface result in a unique relationship between uncommanded roll rate and airspeed. Therefore, if the uncommanded roll-off behavior of an airplane is obtained, the information could be used to identify the actual flight control surface causing the uncommanded rolling

moment. The simulator data for the CR configuration is presented in figure 2.
